MEMORANDUM  
INTERMOUNTAIN POWER SERVICE CORPORATION  
INTERMOUNTAIN GENERATING STATION

SUBJECT: Follow up Report Concerning the Cooling Tower Fan Blade Resonance and Ceramic Cooling Towers Proposed use of a Ten Blade Fan System

REFERENCE: Letter, dated January 29, 1987, Resonance of Cooling Tower Fan Blades may be causing fan failures.

## Fan failures traced to blade resonance excitation by the innovative use of instrumentation

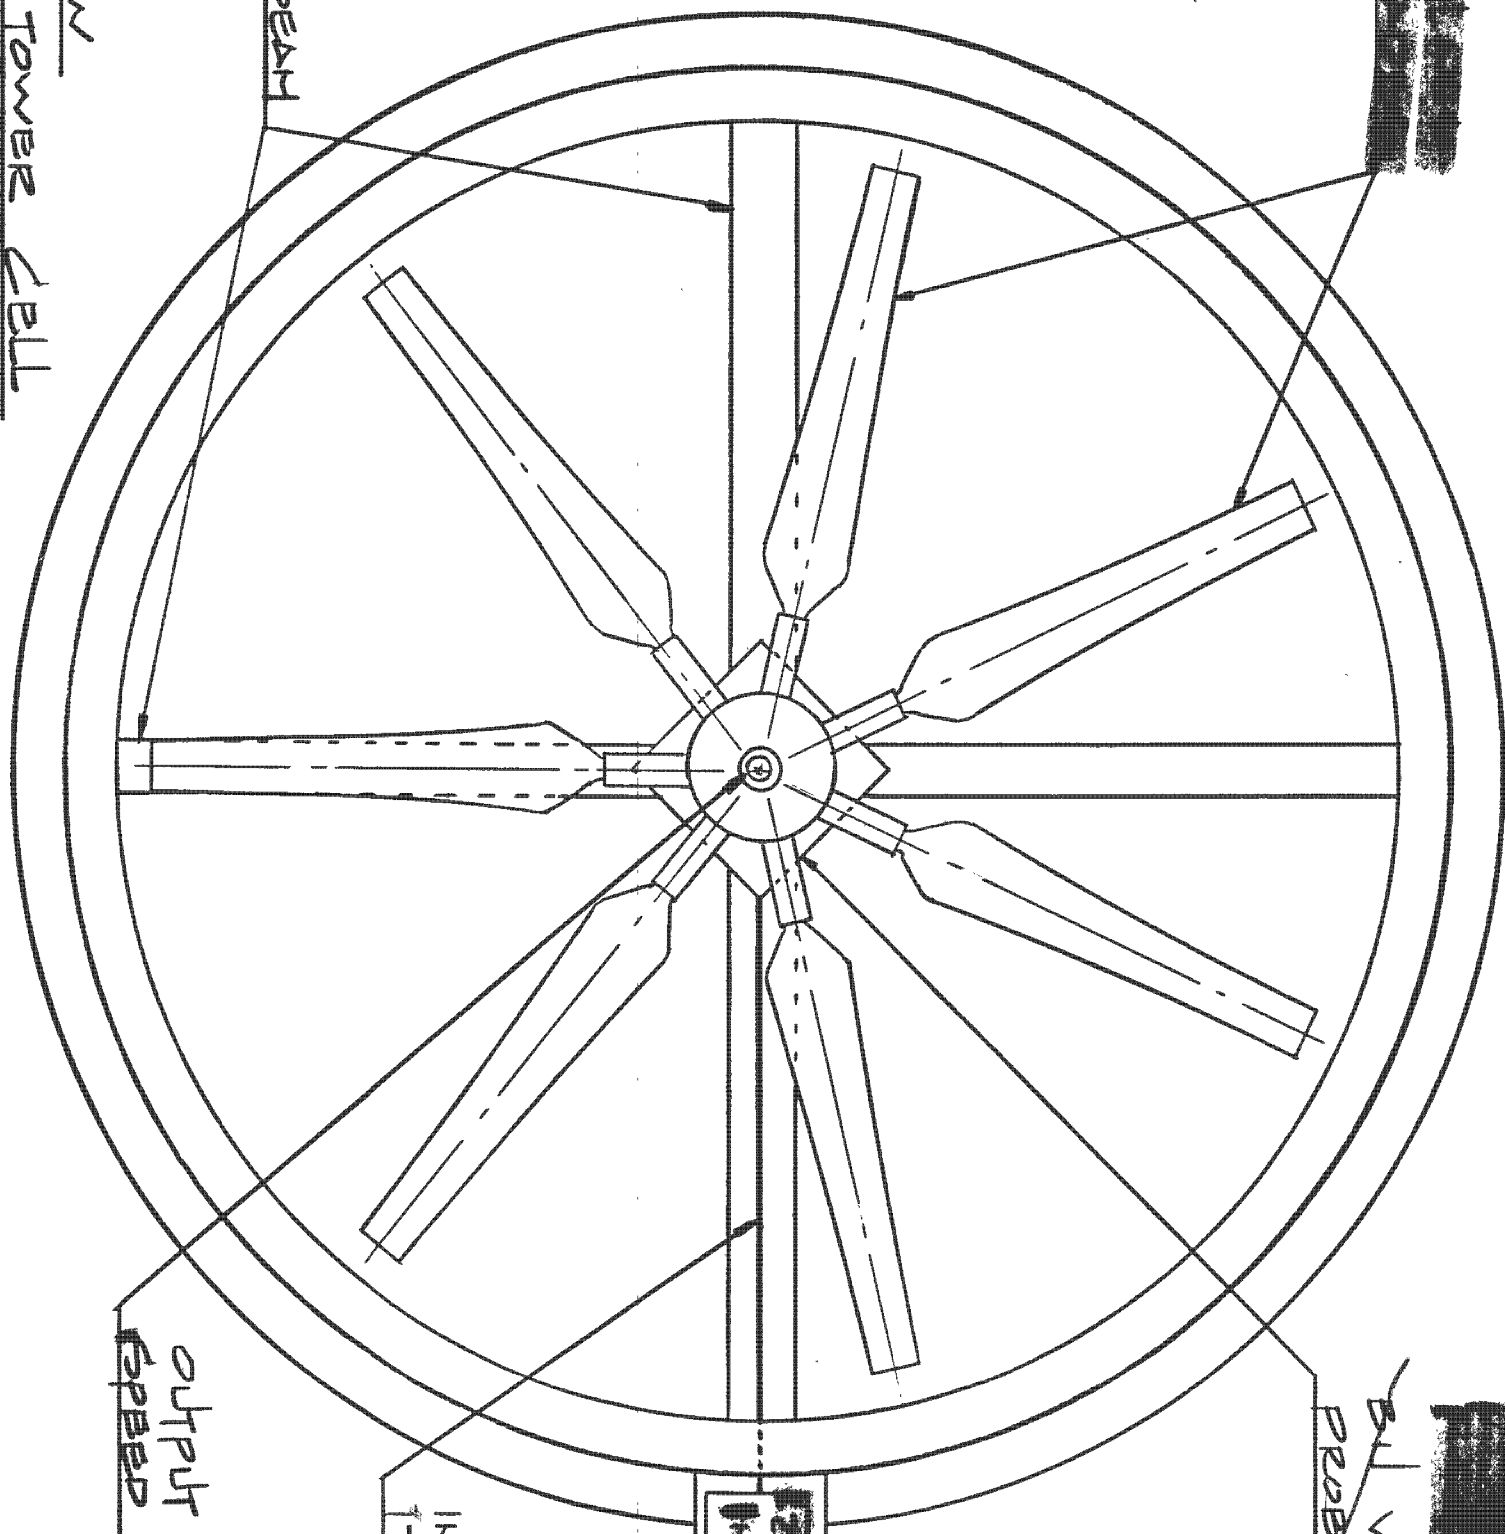
TOP VIEW  
COOLING TOWER CELL

Each fan cell is composed of a fan with seven blades, a gear reducer mounted on a pedestal, and four concrete beams. The concrete beams stabilize the fan and gear reducer in the middle of the fan stack (Refer to fig. 1). The gear reducer input and output shaft speeds are 1785 and 103 rpm respectfully. Many vibration tests have been performed on Unit 1 & 2 fans by using the Bently Nevada (BN) absolute velocity probe mounted on the gear next to the input drive shaft (Shown on fig. 1).

It was discovered by observing the integrated accelerometer time base signals and frequency spectrums that a reverse (against rotation) "wobble" of the fan blade hub was occurring. As can be seen in Figure 1, a blade that was positioned over the beam and in an unloaded condition would be followed .02 seconds later by the next blade to become unloaded, approximately 103 degrees against rotation, from the previously unloaded blade. This phenomenon made the hub wobble against the rotation of the fan.

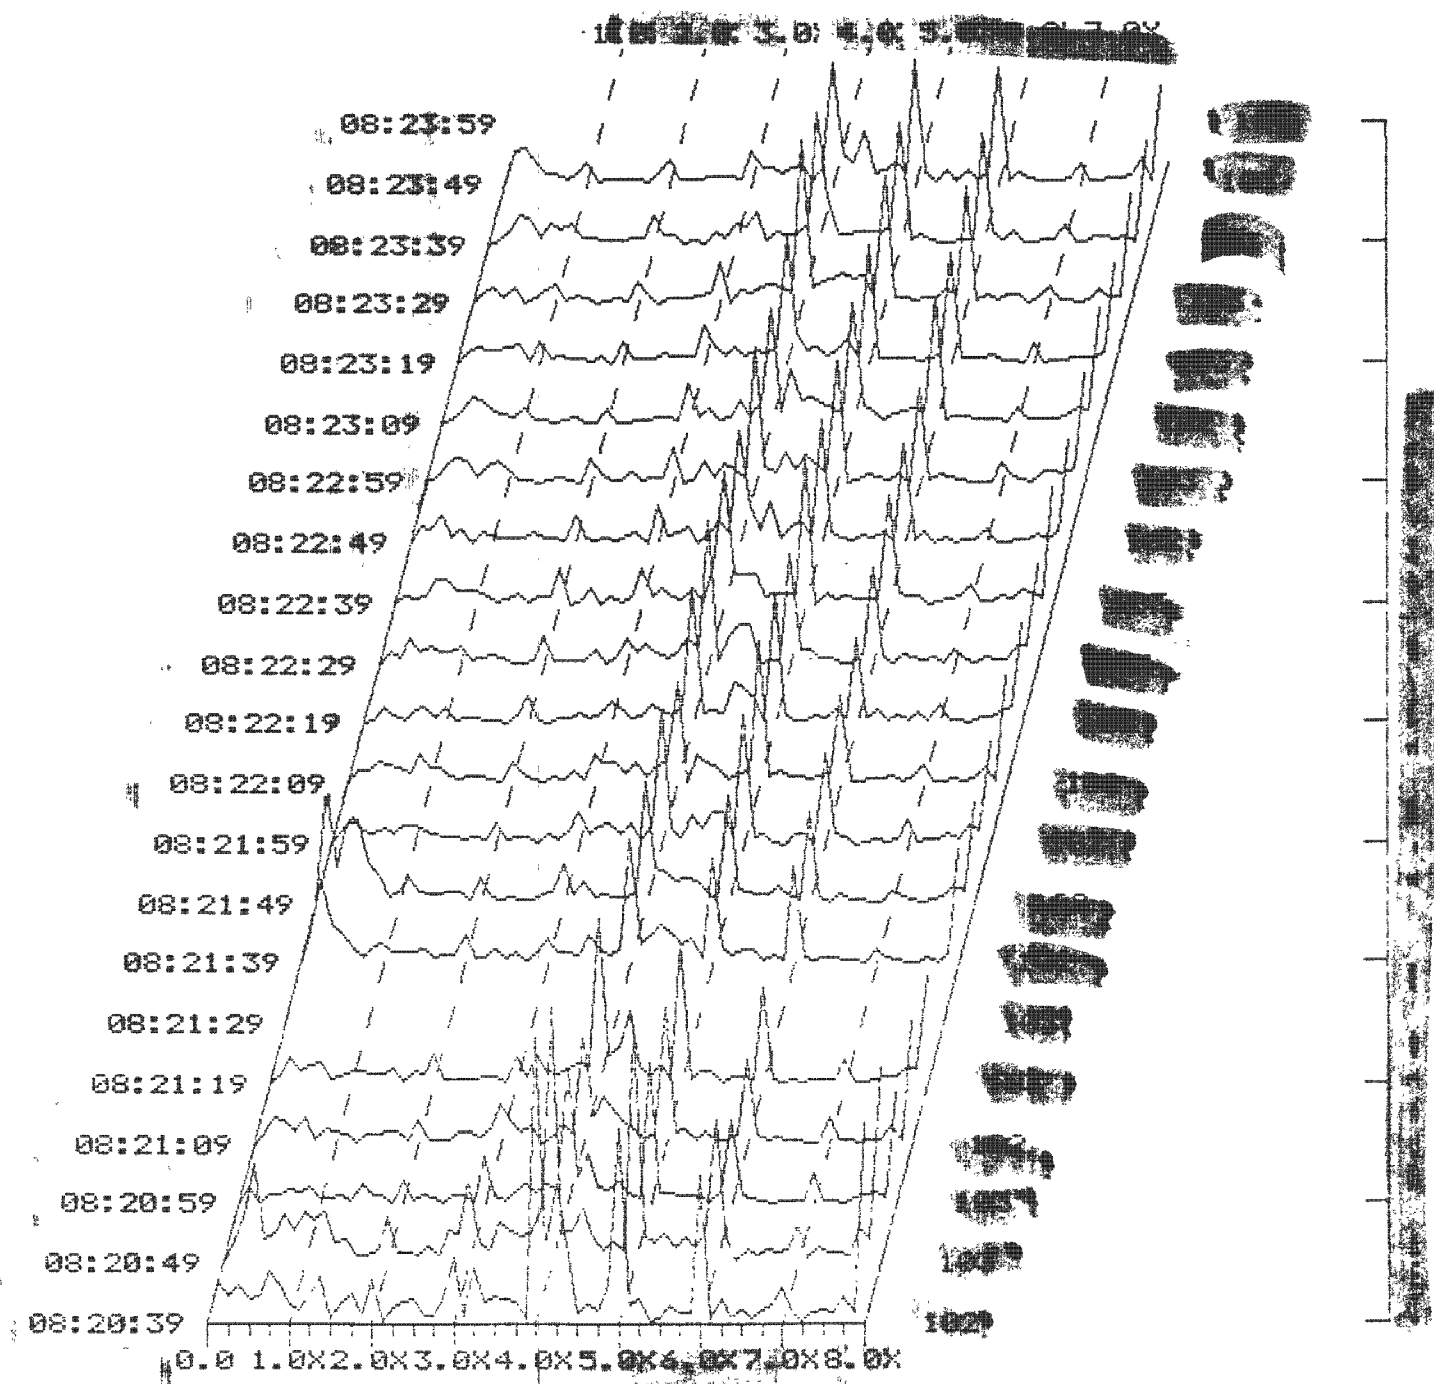
Fig 4

Figure 4 shows 21 samples of the running data taken at 10 second intervals. Since the Keyphasor signal was recorded simultaneously with the accelerometer signal, this plot was labeled in terms of multiples of running speed, commonly referred to as "X" (e.g. 1X, 2X, etc.). The data taken at 08:23:29 was selected as being typical of the average of the 21 spectrums (Figure 5). This plot indicates a high 4X component which was found to be related to the fan cell design.

Waterfall diagram showing spectrum samples taken at 10 second intervals

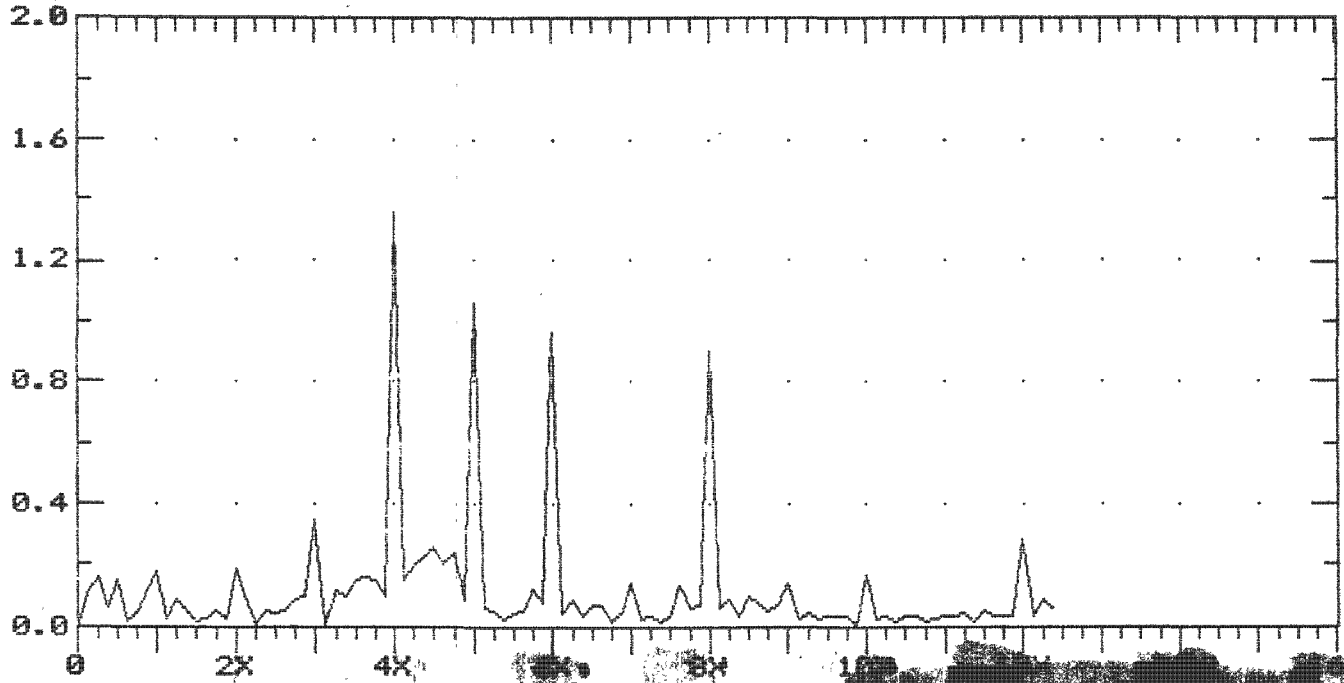
The design of the fan cell is such that in the normal operating mode, the fan blades "load up" as they perform work. This loading up is caused by the movement of air through the cell. The loaded blade condition is constant except when the blade passes over one of the four concrete support beams in the cell. When a blade is positioned over one of the beams, the air path is momentarily interrupted. This flow interruption actually causes a brief unloaded condition on the blade. This loss of load occurs four times per fan revolution on each blade. Therefore, each blade was excited at 4 times the fan speed of 103 rpm, which produced the 4X frequency of 412 cpm.

The high 4x frequency component was found to be related to the fan cell design.

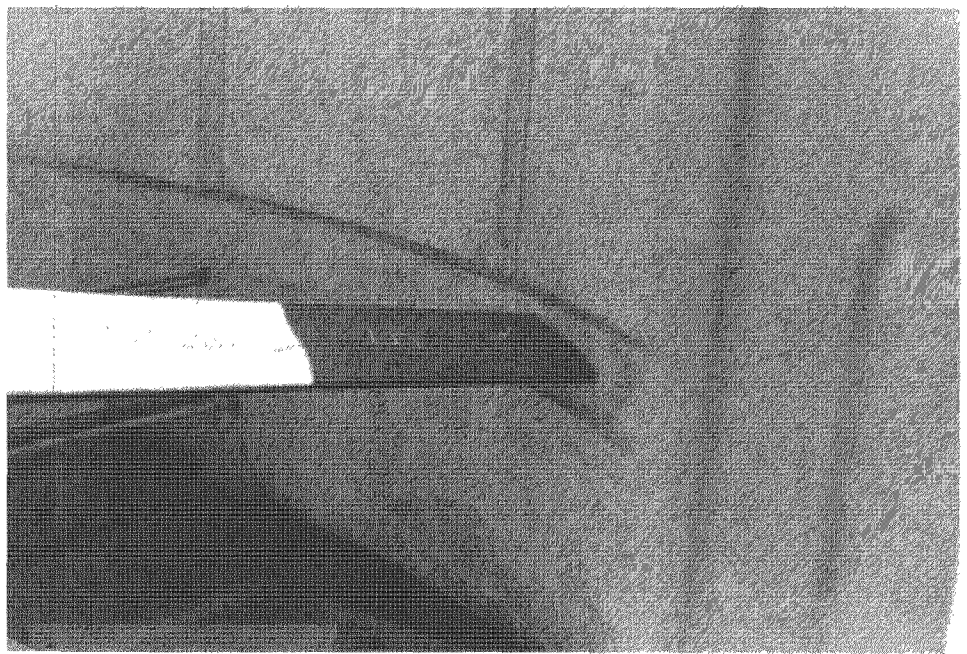
PICTURE # 1

Fan cell 1A03 was selected for this special vibration test because of several tripping problems due to a blade droop switch being activated. Acceleration probes were mounted at the end of three of the seven blades, (see picture #1). A cable was then run from the probe to a recorder and power system, which were mounted in the center of the fan hub, (see pictures 2 thur 5). A key phaser was also attached to the fan hub and referenced to a point on the gear reducer. With this unique setup, vibration data concerning the blade movement could be obtained while the fan was in operation.

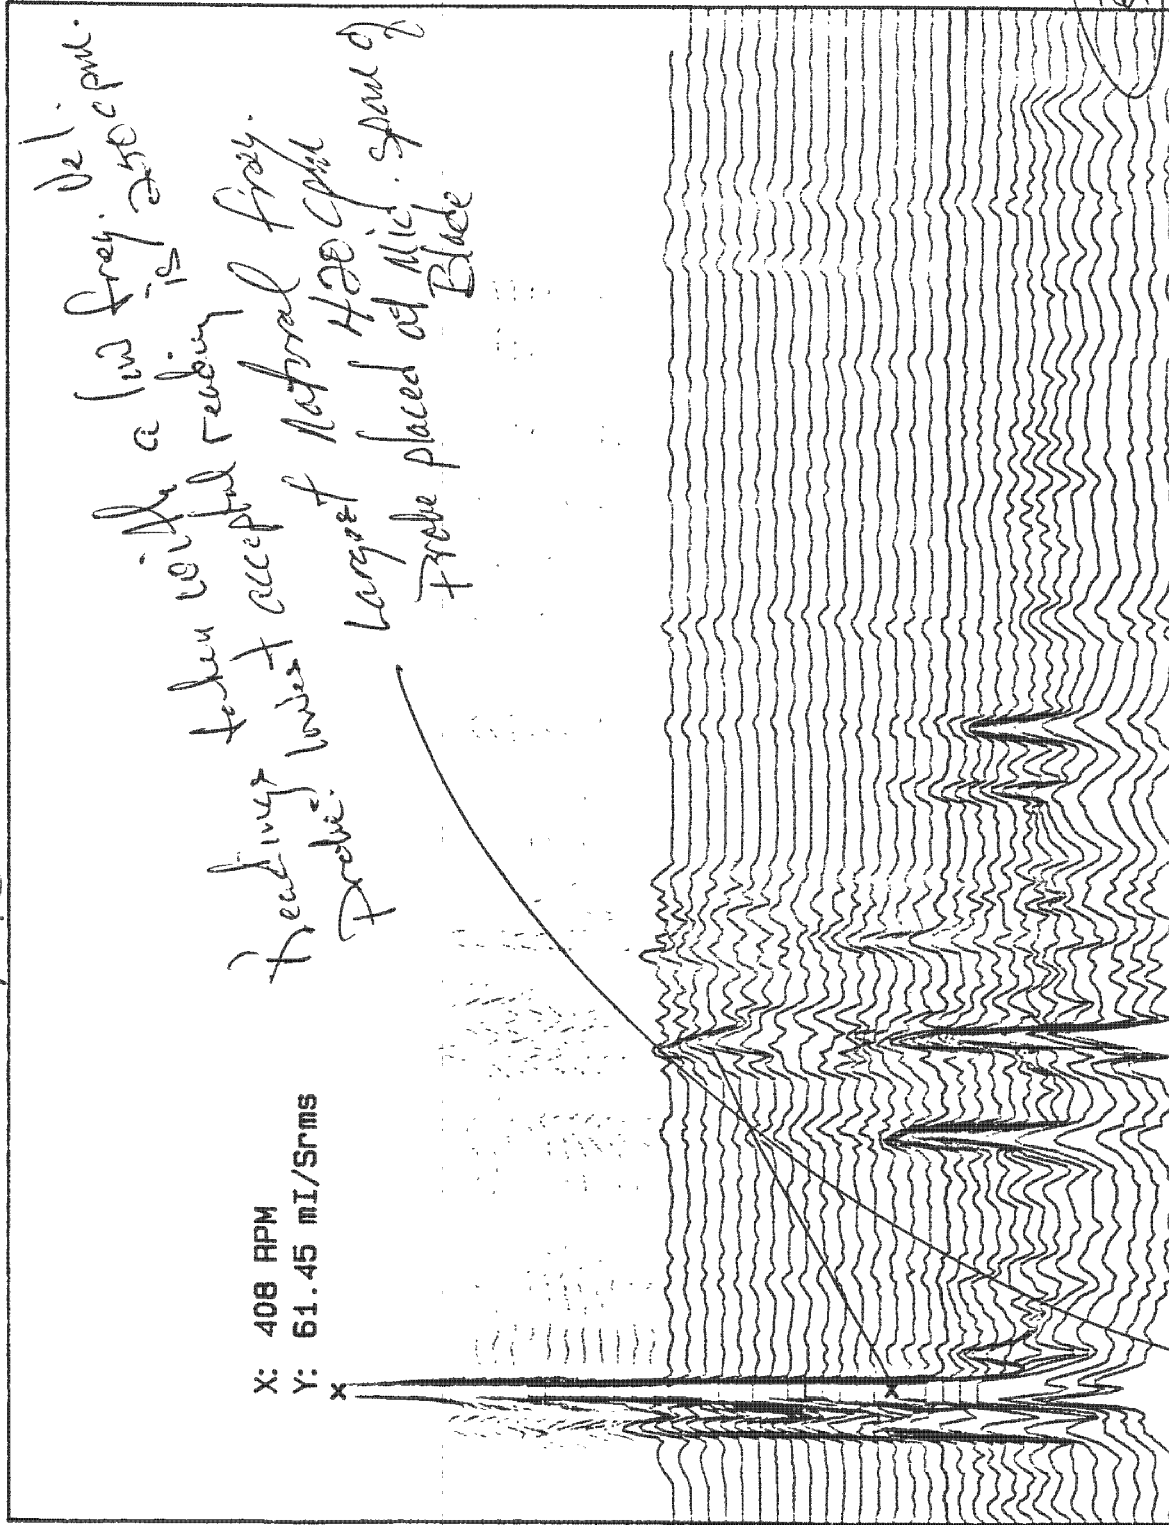
ATTACHMENT # 2

In order to determine if the individual blade vibration was normal, a natural frequency or resonance test was performed on a few cooling tower fan blades in cell 2A02. Two types of transducers were used to monitor the magnitude and natural frequencies of the blades as they were excited. A low frequency absolute velocity probe was located at a position mid-span to the blade and an acceleration transducer was mounted on the tip of the blade. Both transducers were located in a vertical direction similar to the normal flow path through the cell. The velocity and acceleration measurement devices indicated a very active 1st resonance or natural frequency of 408 - 420 cpm. This test was performed several times to verify its accuracy (see attachments 2 & 3).

Natural freq. test on Nelson 30' Hds. Test was performed at Cell 2A02°
